Agricultural Resources

Barns

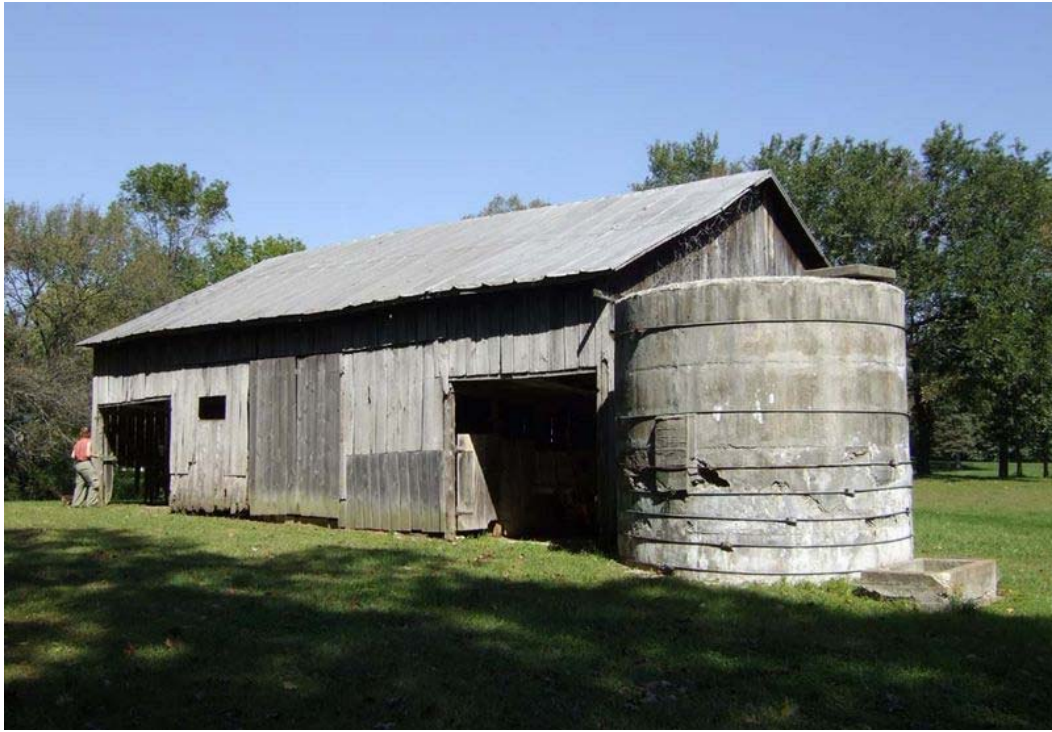
Figure 237: *WS 315, Multi-purpose Barn, early-mid twentieth century, Fredericktown vicinity. A modified English barn with extended end sections for storage of farm machinery. The central section has stables, and hay was stored in the loft. The concrete structure in the foreground is a cistern.*

Another important type is the English barn, which could serve the same purposes as the Transverse frame barn. The English barn has its aisle running through the center across the gable rather than parallel to it (Figure 236), and typically has three sections on the ground floor, the center aisle and the bays on either side of the aisle. Just 17 barns of the 616 we have classified by type are English barns, but the form was much more common in the antebellum period, so documented examples are sometimes early. In some cases, however, the form continues to be built late, even into the 20th century, as at WS 315 (Figure 237).

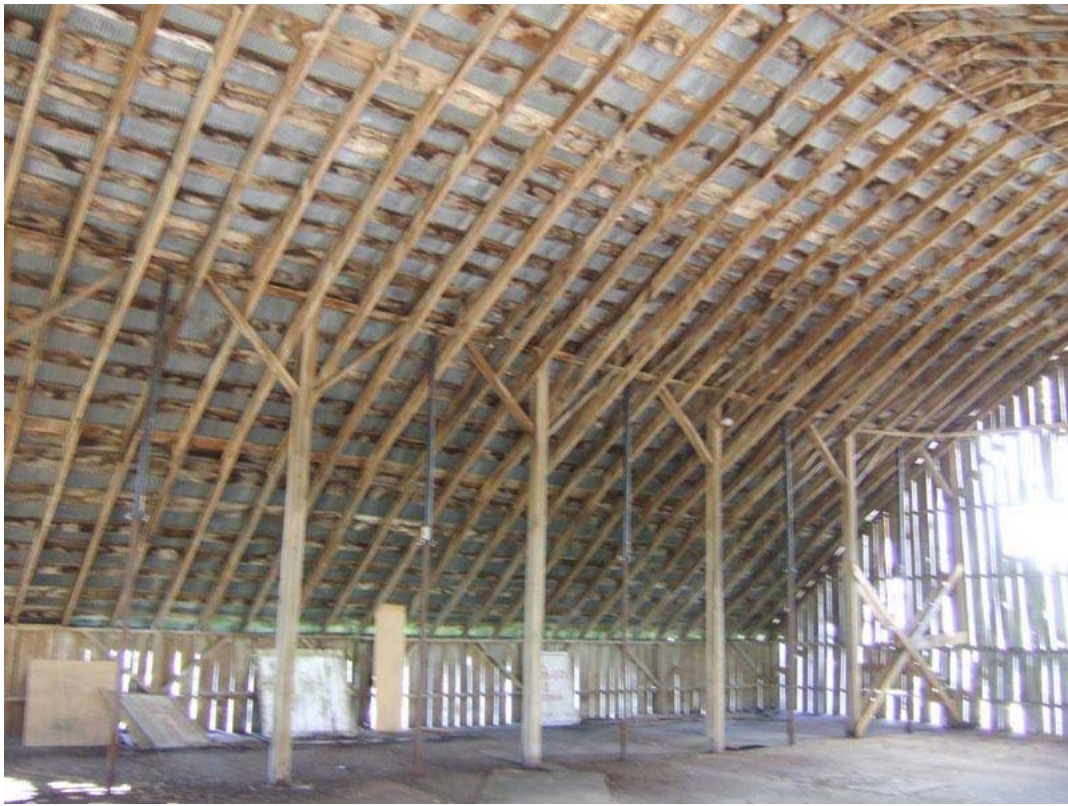
Figure 252: *WS 314, Dairy Barn, early twentieth century, interior view of loft, Fredericktown vicinity. See also Figure 277.*

were engineered that allowed the load of the roof to be carried down to the foundation without the intervening posts and braces. In stock and dairy barns with hay loft storage, this trend toward more open space with fewer interruptions from posts (WS 324, Figure 252), ultimately led to lattice or laminated truss examples with no posts interrupting the loft at all (MN 188, Figure 253). Tobacco barns, however large they became, are at the opposite extreme internally, with the interior space tightly crisscrossed with posts and rails upon which to hang the tobacco (WS 403, Figure 254).
